January 16, 2025

Service Letter ACSL-SOTEN-SB24-018

ACSL TAKEOFF for SOTEN

Version 1.16.0 Release Notes

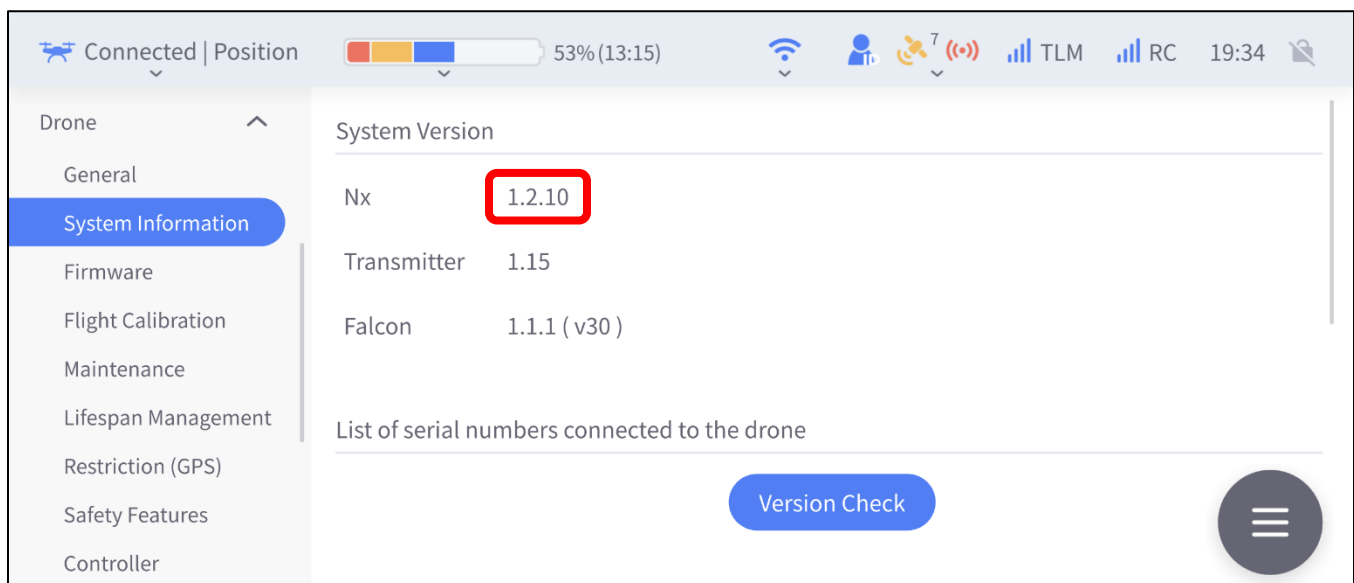
The ACSL TAKEOFF for SOTEN ground control application version 1.16.0 includes SOTEN aircraft (Nx) firmware version 1.2.10, CX-GB100, CX-GB300, and CX-GB400 camera firmware version 1.20, and CX-GB200 camera firmware version 1.21. When the SOTEN aircraft is successfully updated, the "System Information" tab in the "Settings" view of the TAKEOFF application should indicate "Nx 1.2.10" as shown in Figure 1.

Figure 1. ACSL TAKEOFF ground control application "System Information" tab.
*Note that "Falcon 1.0.9" may be displayed without any change in functionality.

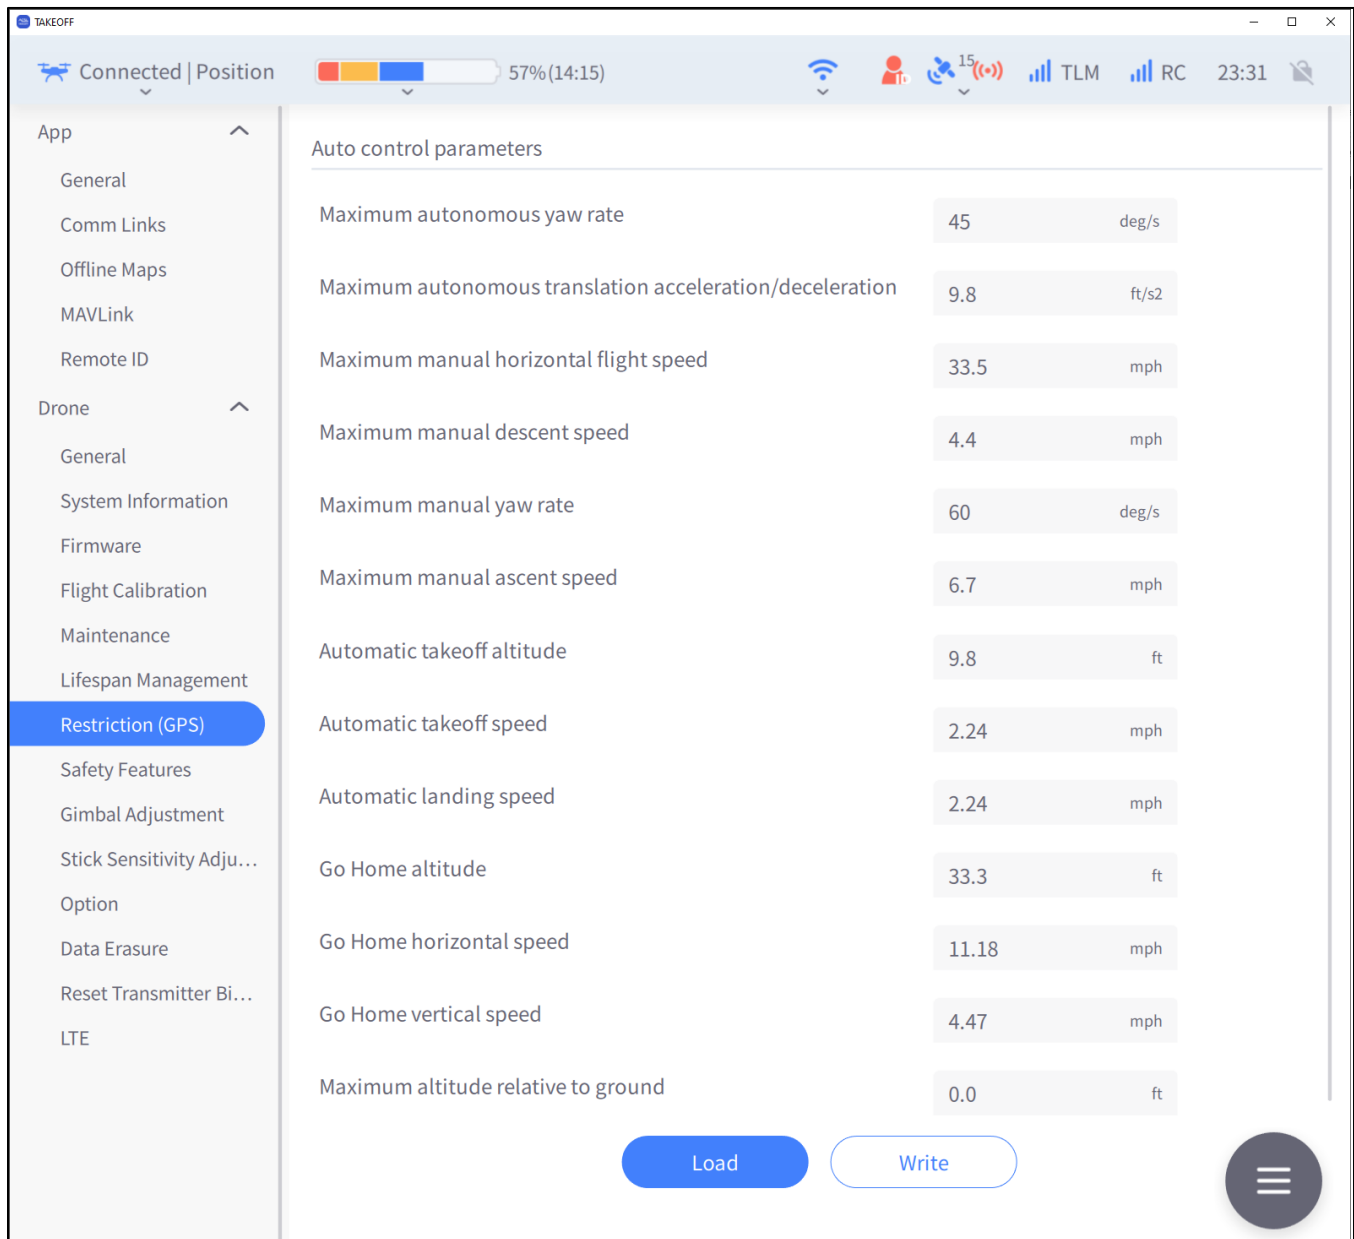
When the SOTEN aircraft is updated with the firmware that is included with this version of TAKEOFF **some of the aircraft settings will be automatically reset to their default values**. Any previous changes to those aircraft settings will not be retained. If you wish to keep the current settings, make a record of the settings prior to the update and reenter those settings after the update. The settings that will be reset are summarized in the screenshots below.

- Restrictions (GPS) settings will reset those shown in Figure 2.

Figure 2. The Restrictions (GPS) default settings.

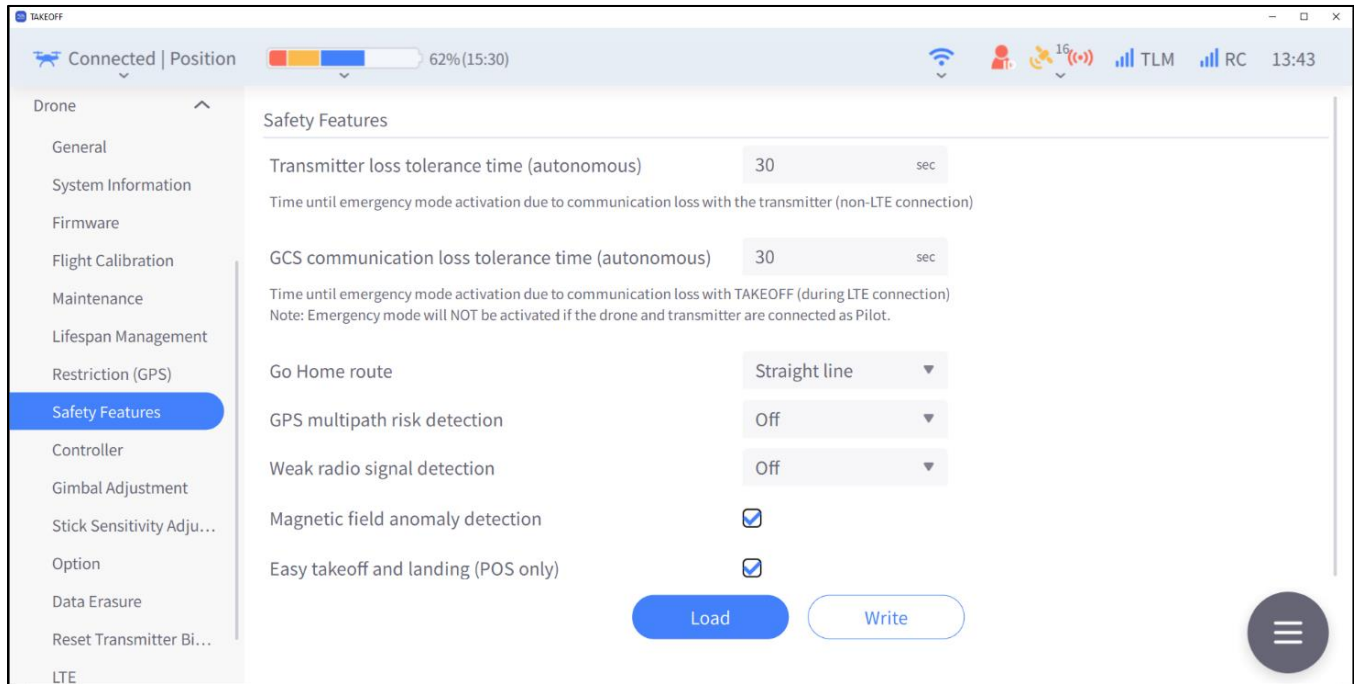
- The Safety Features settings will reset to those shown in Figure 3.

Figure 3. The Safety Features default settings.

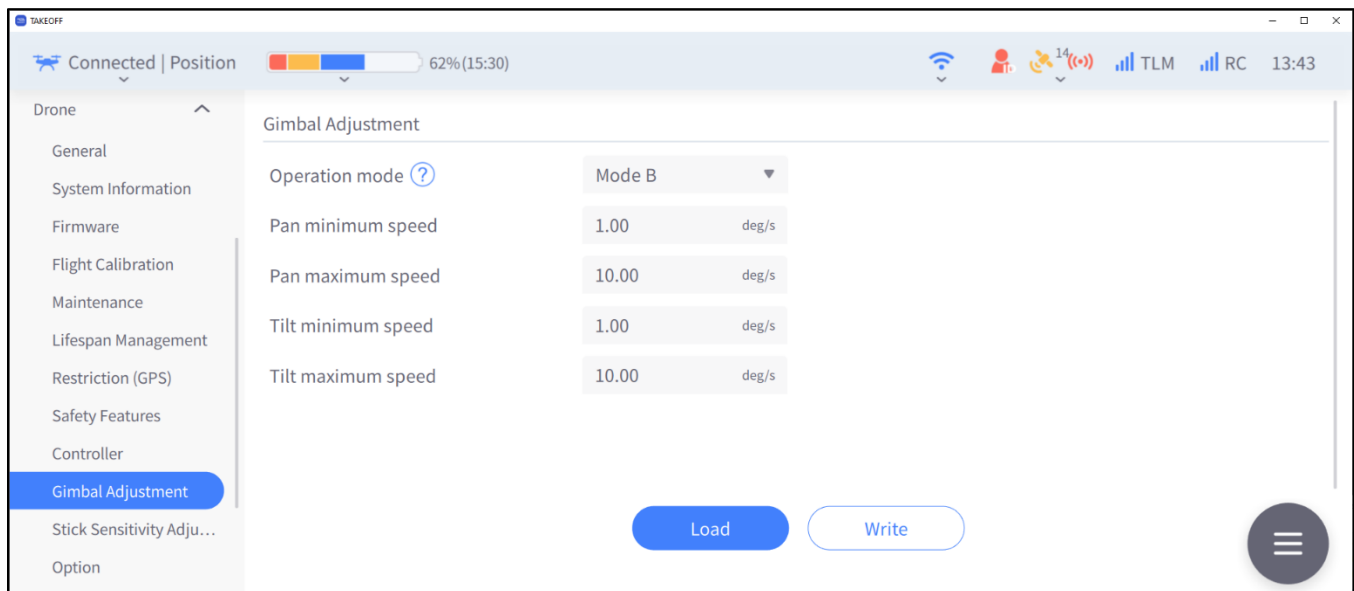
- The Gimbal Adjustment settings will reset to those shown in Figure 4.

Figure 4. The Gimbal Adjustment default settings.

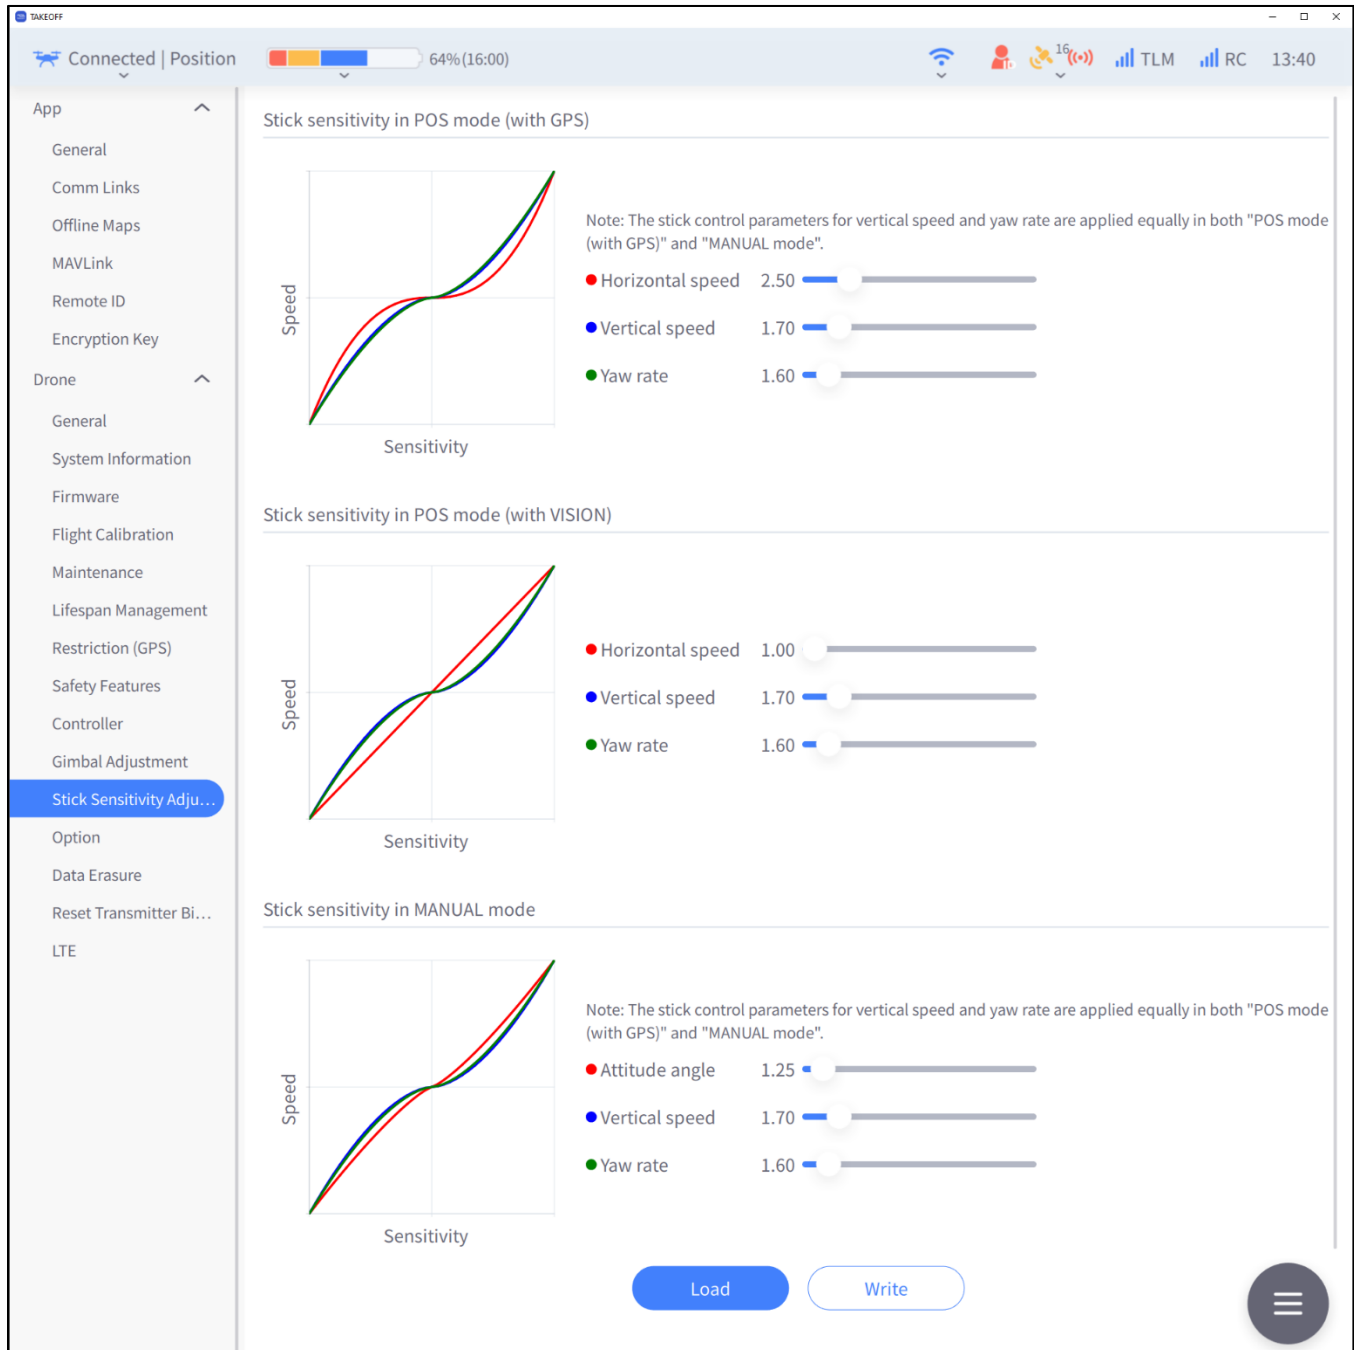
- The Stick Sensitivity settings will reset to those shown in Figure 5.

Figure 5. The Stick Sensitivity default settings

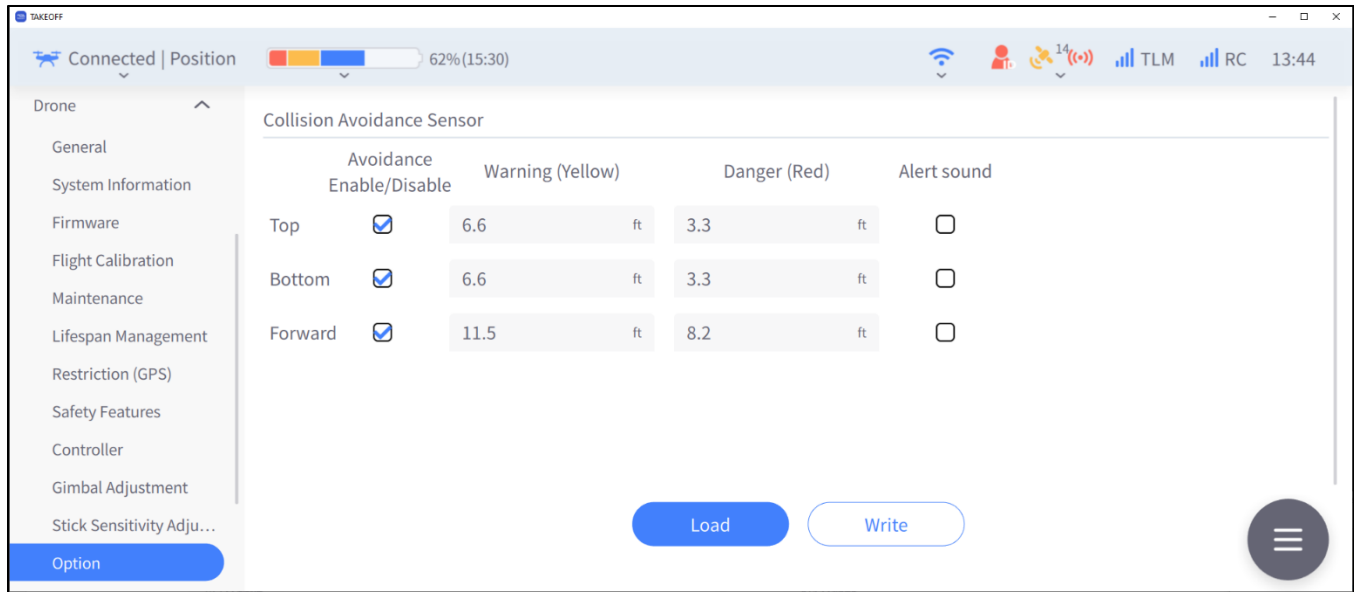
- The Option settings will reset to those shown in Figure 6.

Figure 6. The Option default settings.
